## Chapter 5

### Ice Jam Mitigation Case Studies

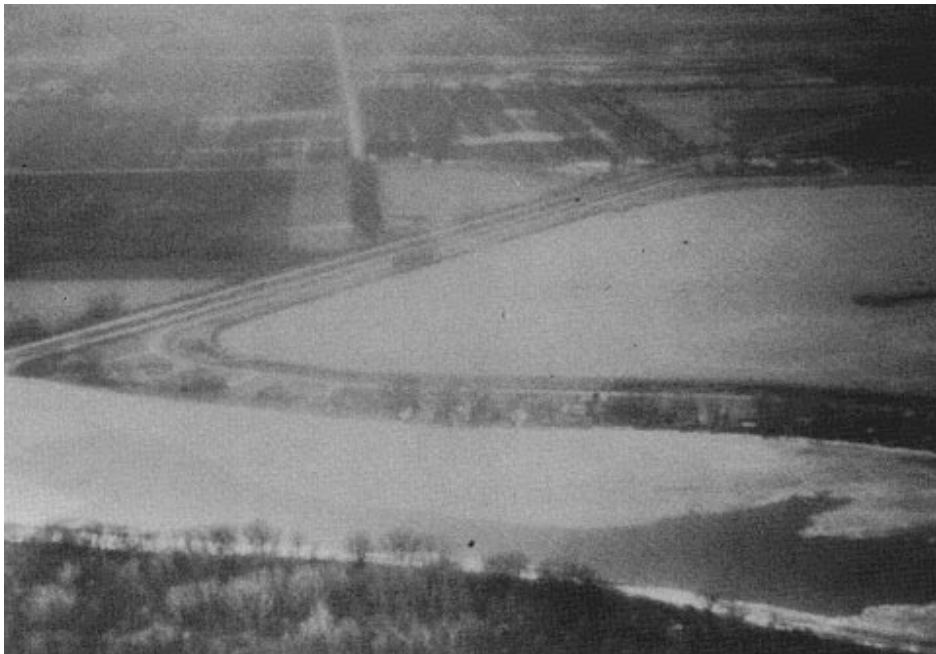
Figure 5-2. Map of meltout

*b.* In a demonstration project, 20 °C (68 °F) water from the cooling ponds adjacent to the Kankakee River near Wilmington was siphoned in three 0.76-m-diam (30-in.-diam) pipes into the river upstream of the ice cover for 2 weeks prior to the anticipated breakup in 1988 (Figure 5-1). The maximum siphon flow is 4.25 cu m/s (150 cfs) compared with the expected river flow of approximately 113.2 cu m/s (4,000 cfs). The measured rise in water temperature was less than 1°. The warm water input melted the existing ice so that ice floes passed unhindered during the natural breakup period and flooding was averted (Figure 5-2).

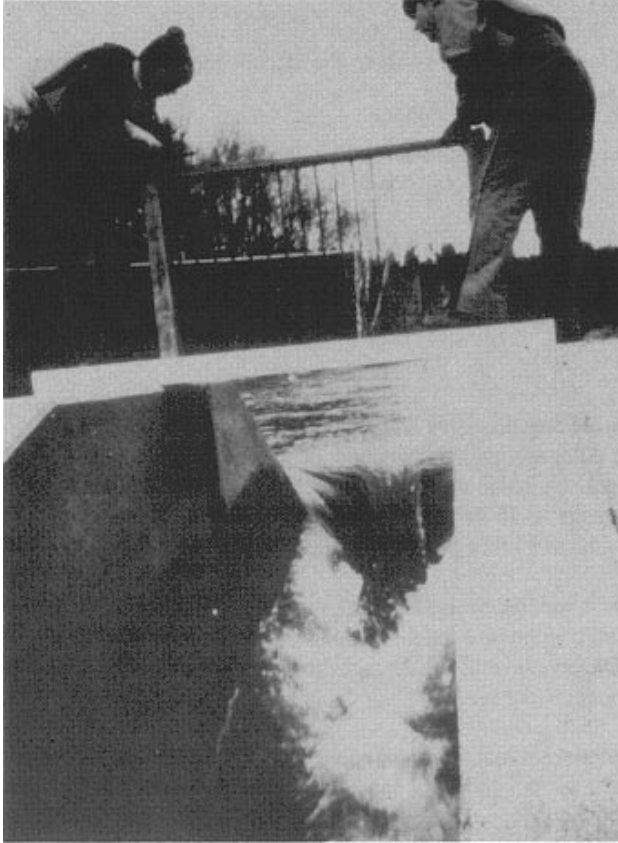
a. Installing racks in sluiceways

**Figure 5-5. Lancaster, NH, weir**

*c.* The ice control weir includes four 1.2-m-wide by 2.4-m-deep (4-ft-wide by 8-ft-deep) sluiceways for fish passage. During the winter, stop logs or metal bar racks are placed in the sluiceways to develop an ice retention pool. The pool forms an ice cover, and frazil ice generated upstream deposits beneath the ice cover. After the ice cover has formed, two of the gates are opened, allowing the pool level to drop. This creates additional water storage in the pool area, provides additional discharge capacity through the weir, and slightly delays the breakup and movement of ice through the pool as well. The project, which cost \$300,000 (approximately \$1,800/ft) was completed in 1982. Although costs constrained the size of the project to less than ideal, no major flooding has occurred since this relatively inexpensive, innovative project was constructed (Axelson 1991).
